Manhole Inspection Summary

Manhole # S17II2001MH

Insp Date: **10/4/06 11:04 AM**

Location Address: **5801 GREELY AVE**

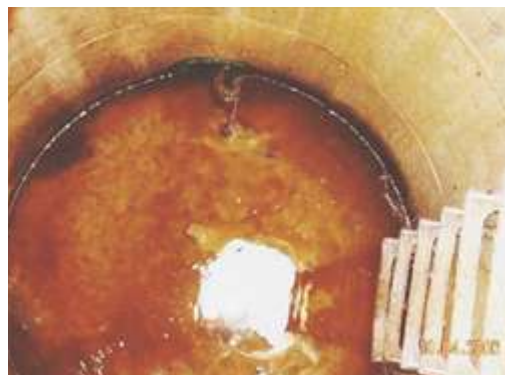
Top View

Comments **The pipe seals are not flush to the pipes. The Channel is below the pipes - there will always be water in this MH.**
